Nu Flow Completes Pipe Rehabilitation Of Naval Fire Training Center

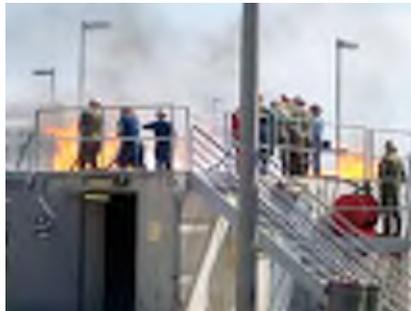
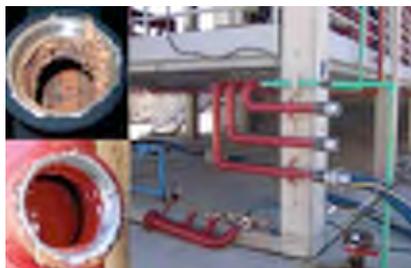
Corrosion was the primary problem in the largest building. Salt air had nearly destroyed the black steel pipe. The best example of this problem was the flange on one of the larger pipes. The threaded section of the pipe was paper thin and had perforated areas. Nu Flow used a false barrier around the pipe while shooting the epoxy, in order to force-fill all the perforations, using multiple applications of epoxy to create a structural coating. Dual coatings are mandatory on larger diameter pipe, but the team paid special attention to the flange and threaded areas to achieve the desired result.

the pipe runs, connections and valves. Next, all valves are removed and air hoses are attached to all of the fixtures. Compressed air and particulate is then used to clean out the entire piping system. Finally, when the system has been dried, an NSF-approved epoxy is then "blown" through the pipes.

The direction of epoxy coating is controlled by a master header that adjusts the level of compressed air sent to various fixtures. The end result is a smooth, epoxy barrier coating between the pipes and potable water, preventing future pinhole leaks in copper and build-up due to corrosion of galvanized pipe.
